## Solving Persistent Shaft Seal Leaks on a 92' Motor Yacht

An AB Yachts owner was facing an ongoing issue with water ingress caused by leaking shaft seals whenever the vessel was underway. Repeated repairs and haul-outs had failed to provide a long-term solution, leading to mounting maintenance costs and unnecessary downtime.

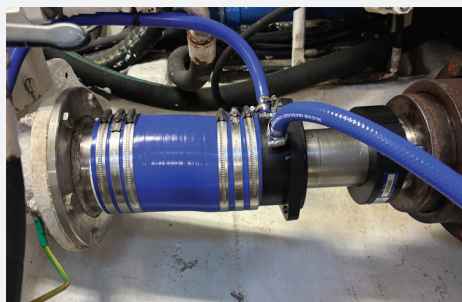
The 92' M/Y Silver Mama was equipped with lip seals that struggled to accommodate severe misalignment between the propeller shaft and stern tube. As the yacht operated, the excessive misalignment placed strain on the seals, resulting in water leakage into the vessel.

*Lip seal installed on M/Y Silver Mama*

To address the issue, a PSS Pro Shaft Seal was installed, incorporating an overbored carbon stator specifically designed to provide greater clearance between the propeller shaft and the carbon stator's inner bore.

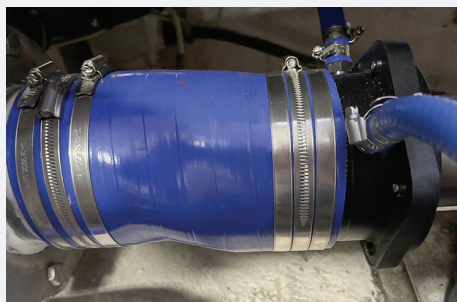
*Closeup of the lip seal and misalignment.*

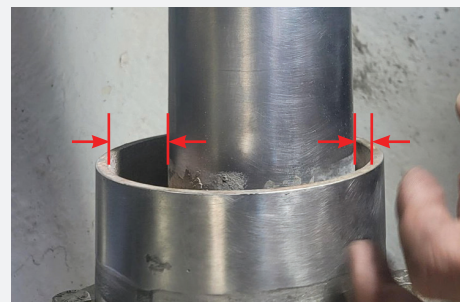
*Propeller shaft off-center within the stern tube.*

This increased tolerance allowed the seal system to better accommodate the alignment conditions present on the vessel while maintaining a watertight seal.

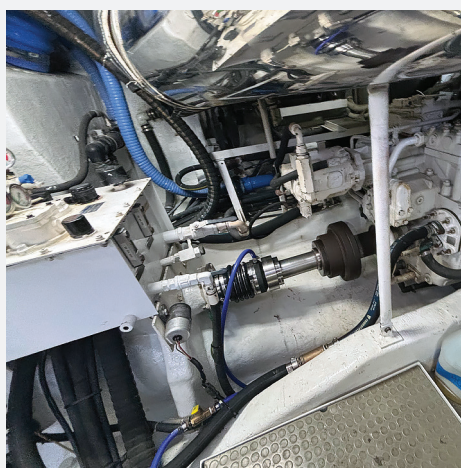
PSS Pro Shaft Seal installed on M/Y Silver Mama

The sea trials confirmed that the new sealing system successfully eliminated water ingress both at rest and while underway.
